**PROJECT NO 043-21 WETTON: 5 BLOEMHOF ROAD ERF511- GEOTECHNICAL INVESTIGATION**

Core Geotechnical Consultants (Pty) Ltd was appointed by Rory Colemim of Arc Timbers cc to undertake a geotechnical investigation for a proposed new residential development to be constructed on erf511 Wetton.

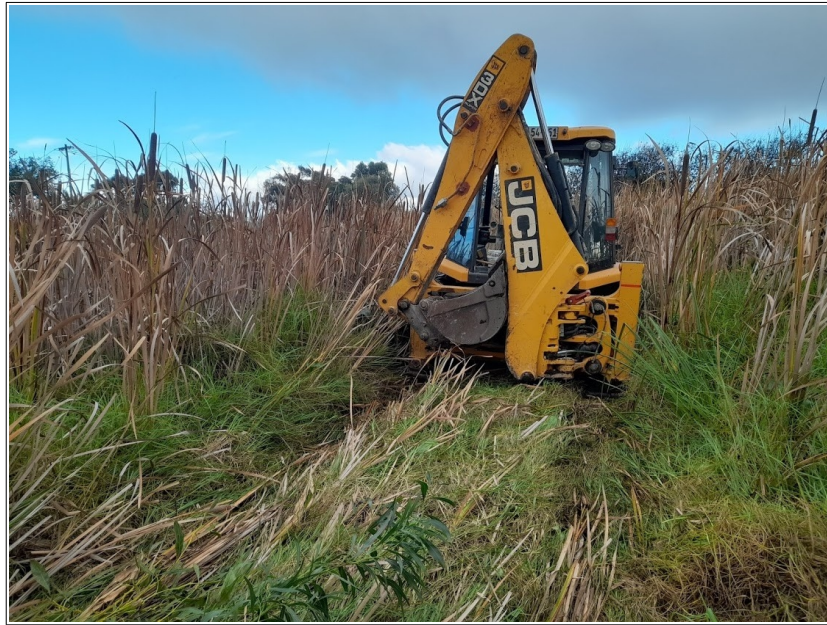
**Figure 3.2: Present site conditions south-eastern portion**

Soils at surface across the site were very moist. This is likely due to recent rains and a moderately impermeable layer of fine grained soils at surface resulting in water to accumulate on surface. A strong flowing water table was observed at a depth of approximately 1,90 m bgl.

In addition to foundation options above, one should consider the marshy conditions. One will likely need to formalise and create extensive site drainage.
